## **ANALYSIS OF THE HAPPYLAND SOCIAL CLUB FIRE WITH HAZARD I**

**Richard W. Bukowski, P.E. and Robert C. Spetzler**  
Building and Fire Research Laboratory, NIST  
Gaithersburg, MD 20899

### **SUMMARY**

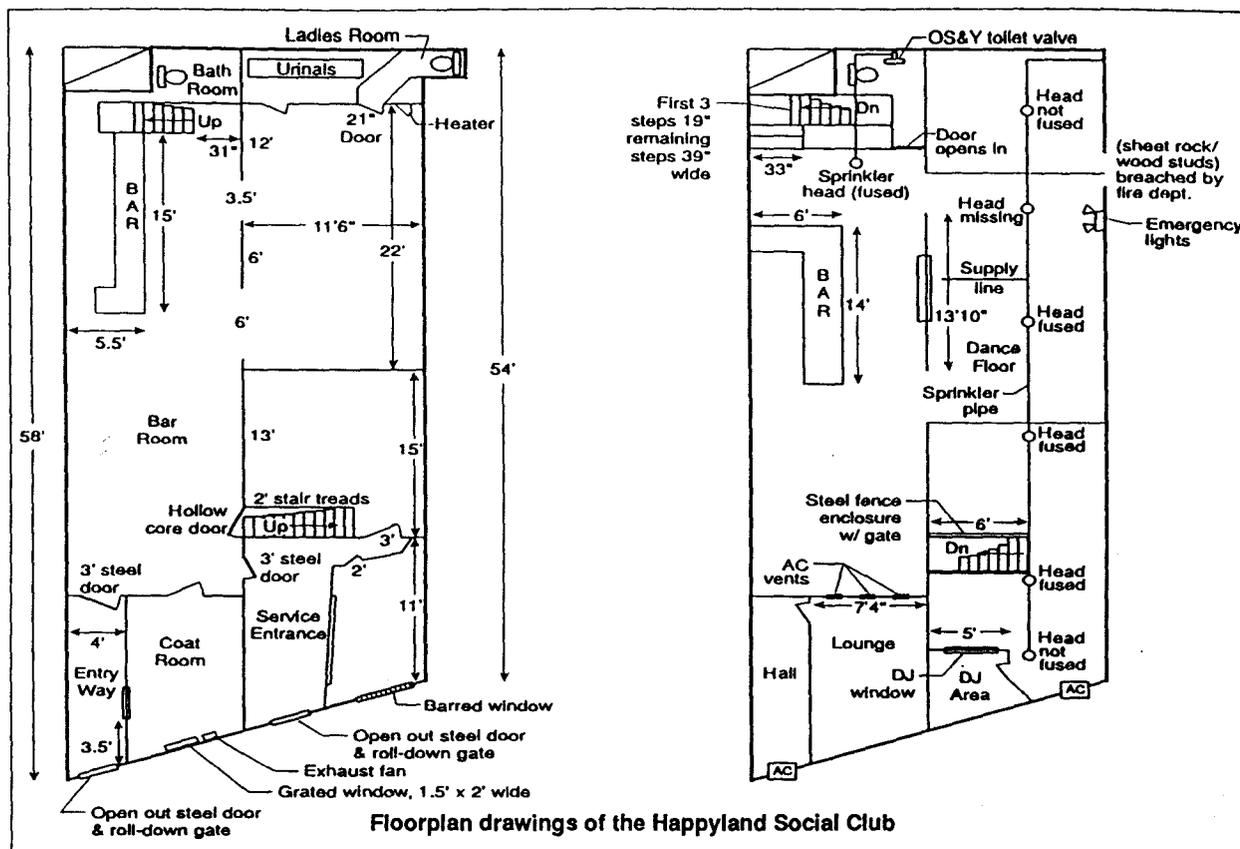
Floorplan drawings of the Happyland Social Club

The floorplan drawings obtained from the New York City Fire Department are shown on the next page. Wall finish throughout the interior of the building was 3/16-inch thick wood paneling on furring strips over plaster. The ceilings were low density fiberboard tiles in the first floor entry and bar, and gypsum board elsewhere. The fiberboard tiles were installed on furring strips under the floor joists. Note the partial sprinkler system on the second floor.

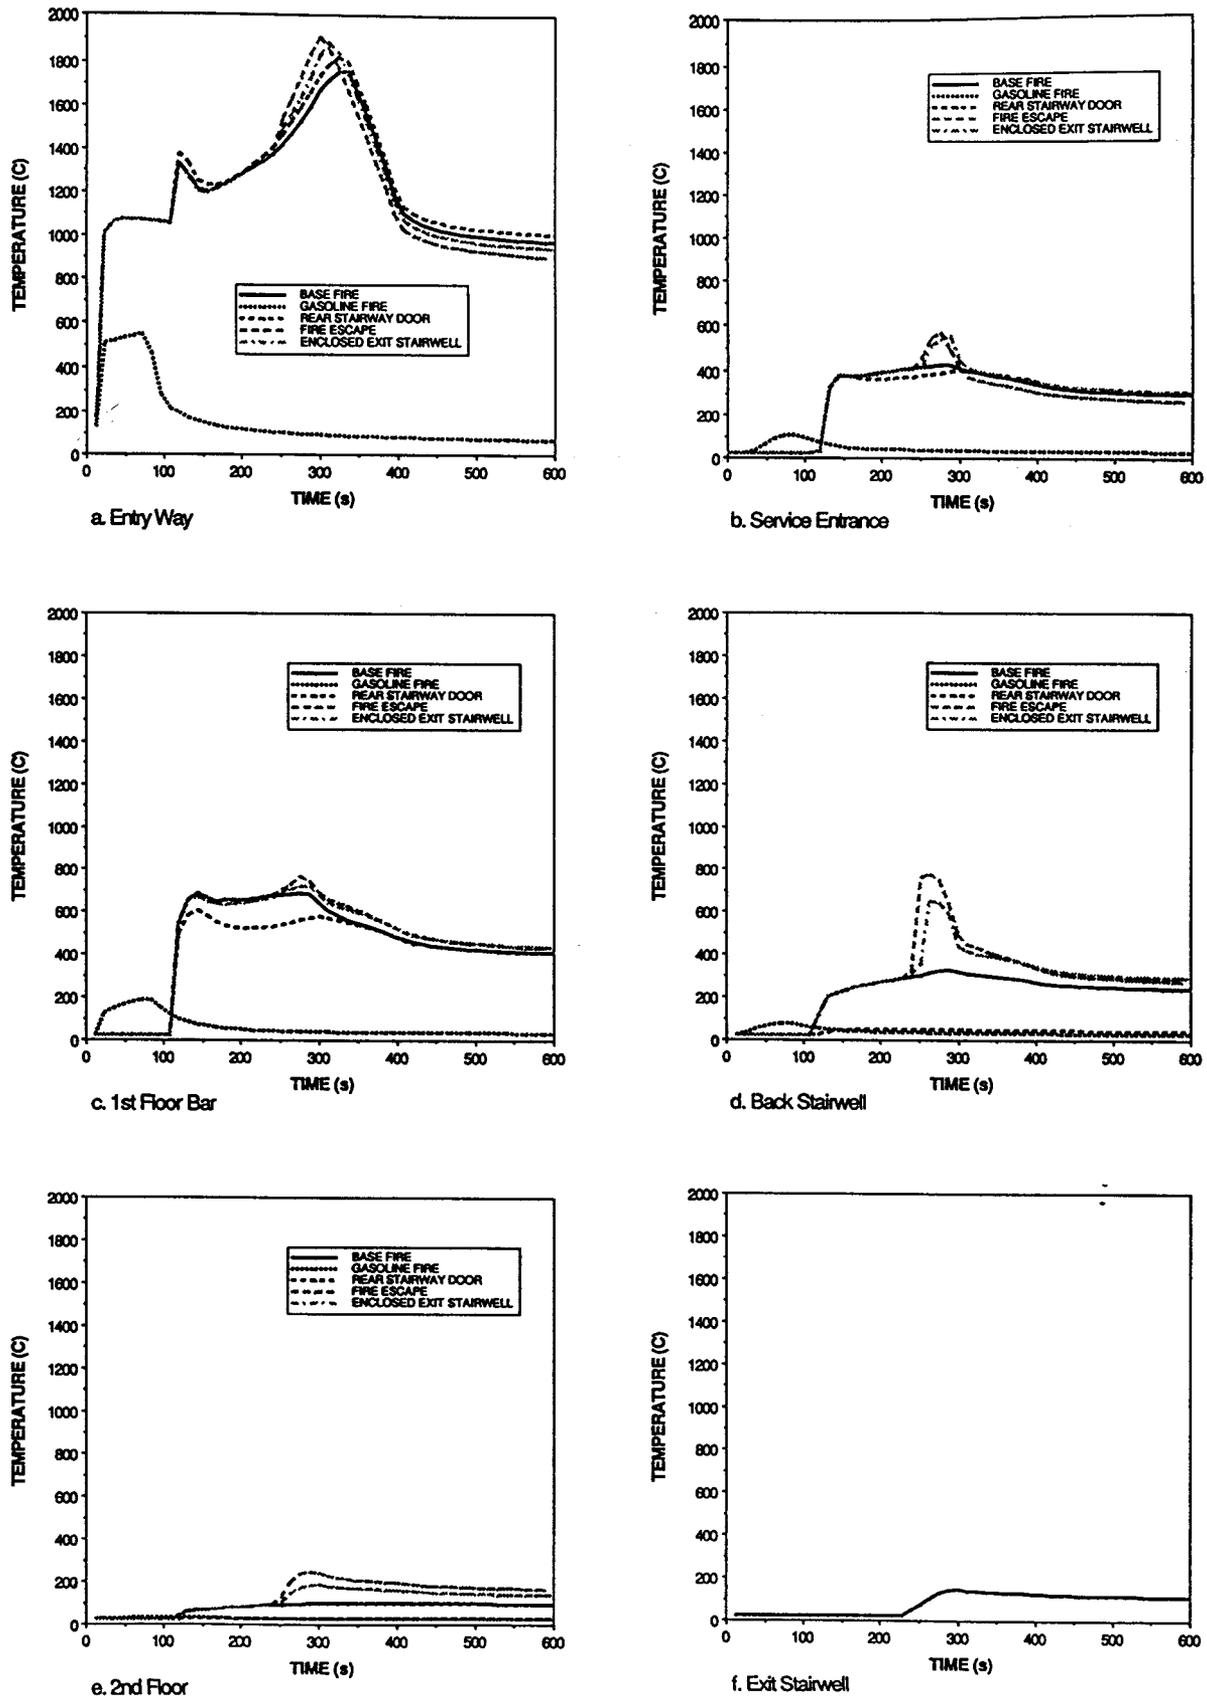
Figure 1. Predicted upper layer temperatures.

It should be noted that the peak upper layer temperatures shown in Figure 1a are too high. Such temperatures reported from experiments rarely exceed 1000°C. Zone models are known to overpredict upper layer temperatures and underpredict lower layer temperatures, because not all mechanisms of energy exchange between layers are included. FAST is no exception, with such overprediction having been estimated at 30–50% under most conditions and higher under severe conditions. Since these overpredictions occur after the times of death, they have little effect on hazard-to-life prediction.

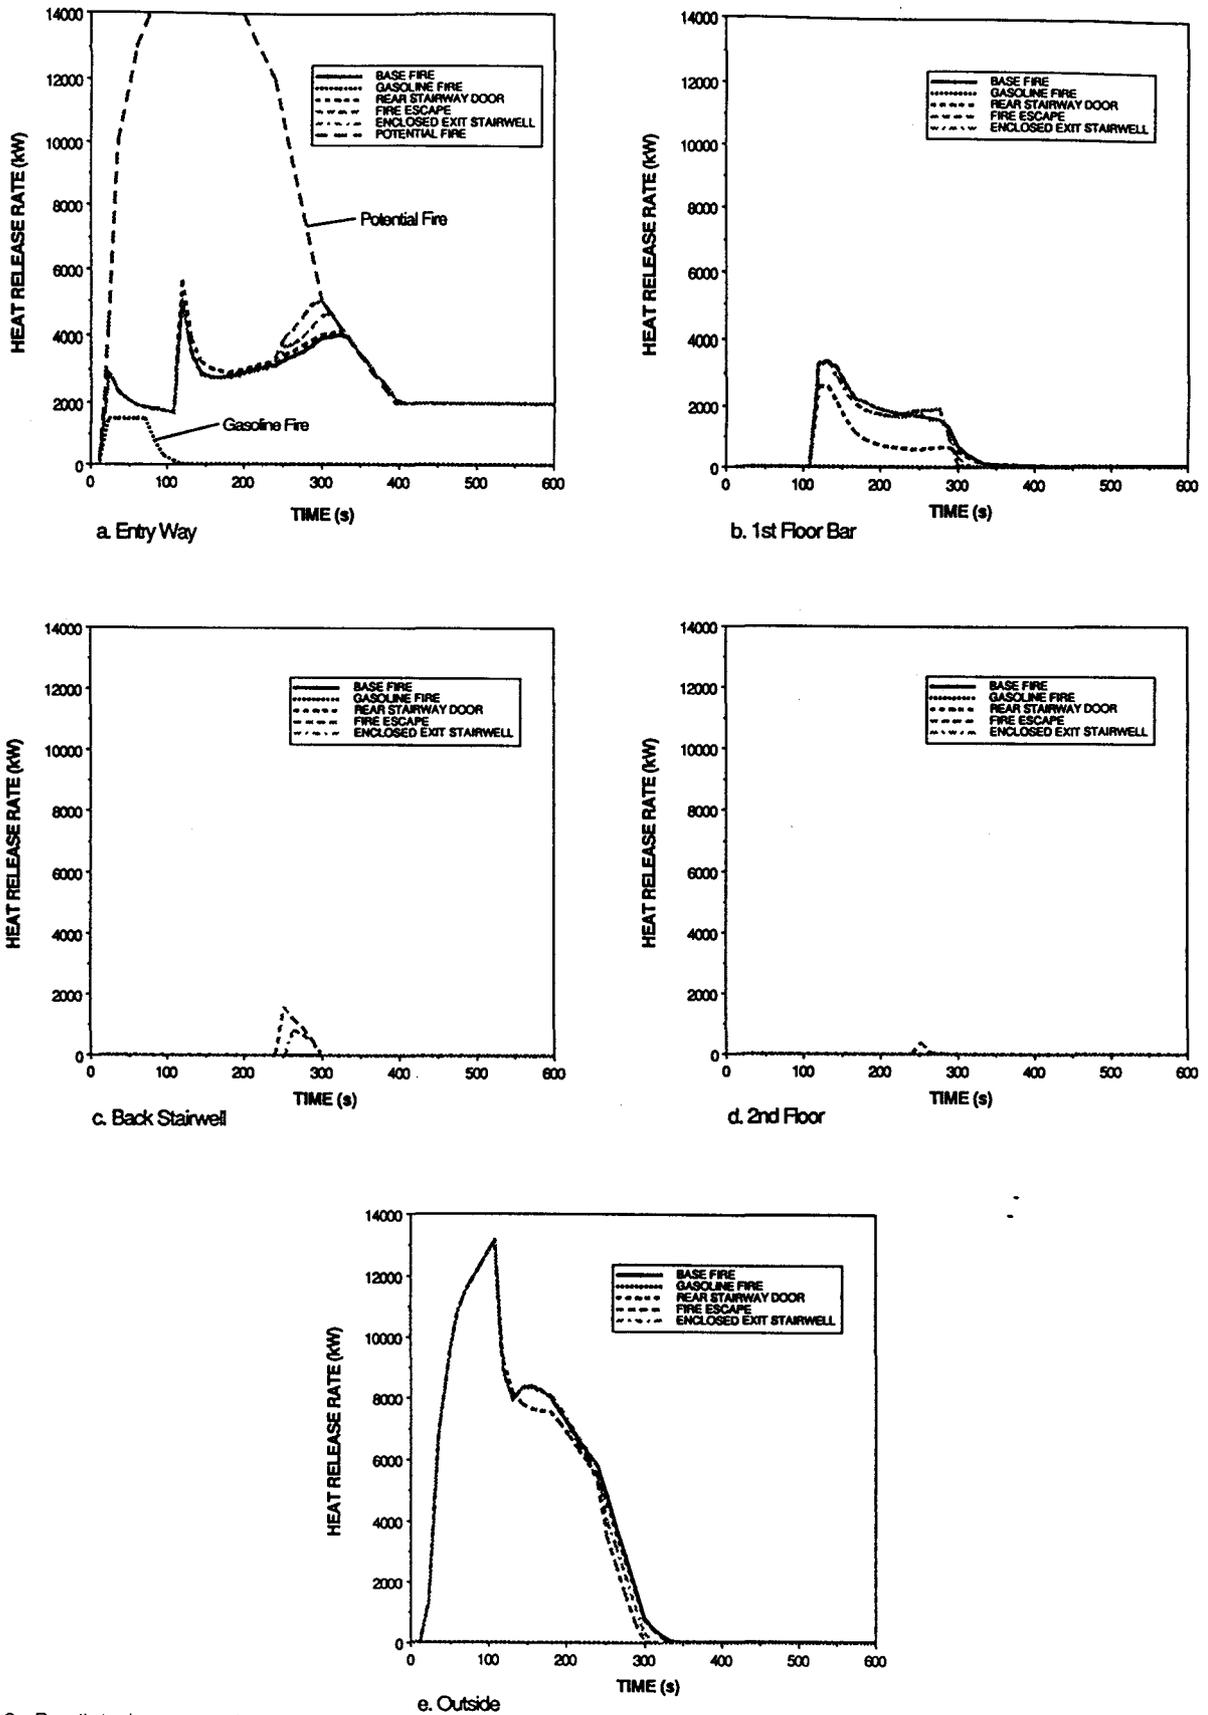
Figure 2. Predicted energy release rates.

procedures in the HAZARD I manual were used. The resulting potential energy release rate profile for the gasoline alone and in combination with the finish materials in the entryway are shown as "GASOLINE FIRE" and "TOTAL POTENTIAL FIRE" in Figure 2a. The difference between the potential rate of heat release and the rates of heat release predicted by HAZARD I for the cases analyzed (except the gasoline fire) results from the impact of the limited air supply. The rate of heat release estimated by HAZARD I for the case where the only combustible material was the gasoline is identical to the potential rate of heat release of the gasoline. This was because the available air supply was sufficient to freely burn all of the gasoline.

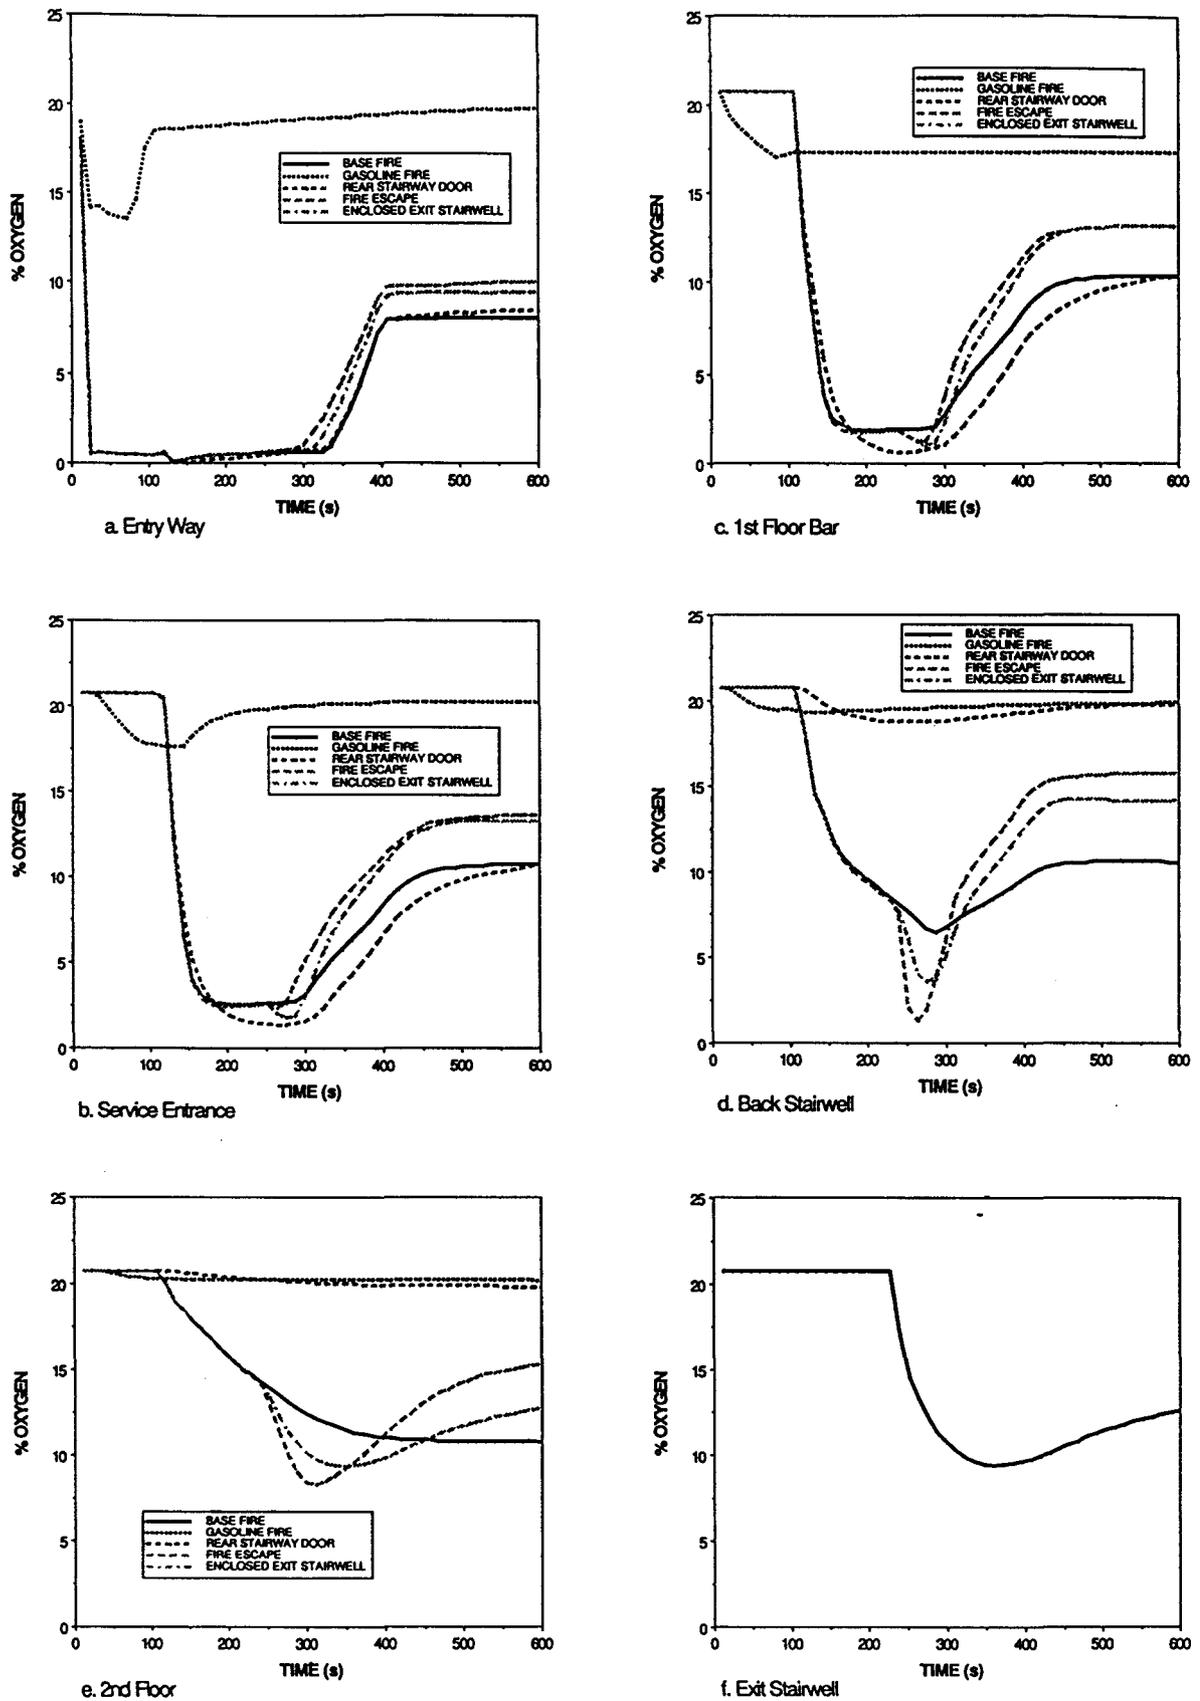
Figure 4. Predicted oxygen concentrations.

The third mitigation strategy involved the addition of an independent, second exit from the upper floor. This would likely be located in the front (street) side as either an exterior, open fire escape with a drop down ladder, or as an interior, enclosed exit stairway descending in the service entry area. The difference between these two is more than just the additional cost of the latter. Opening a second floor door to a fire escape would have changed the ventilation pattern in the building, possibly resulting in a significantly increased flow up the rear stairs to the second floor, making occupant survivability worse. Thus, both arrangements were examined with the model. The results of the predictions showed similar results with respect to each of the examined parameters. In both cases, opening of the egress door on the second floor results in increased flow up the back stairs with an attendant increase in the temperature (Figure 1e) and CO levels (Figure 5e), and decrease in the oxygen on the second floor (Figure 4e). However, these effects were somewhat greater in the case of the fire escape than for the enclosed

When the noncombustible finish scenario was run in HAZARD I, the results indicated that temperatures (Figure 1), CO (Figure 5), and oxygen concentrations (Figure 4) remained tolerable throughout the fire. Only a person in the entryway would have experienced lethal conditions, from burns. With both doors to the entryway open, the gasoline fire had sufficient air to burn out without producing flames out either door, so ignition of furniture in the bar would be unlikely. But if the fire had involved the contents of the bar (e.g., if the fire was started in the bar), some life loss would be likely, even with noncombustible finish.

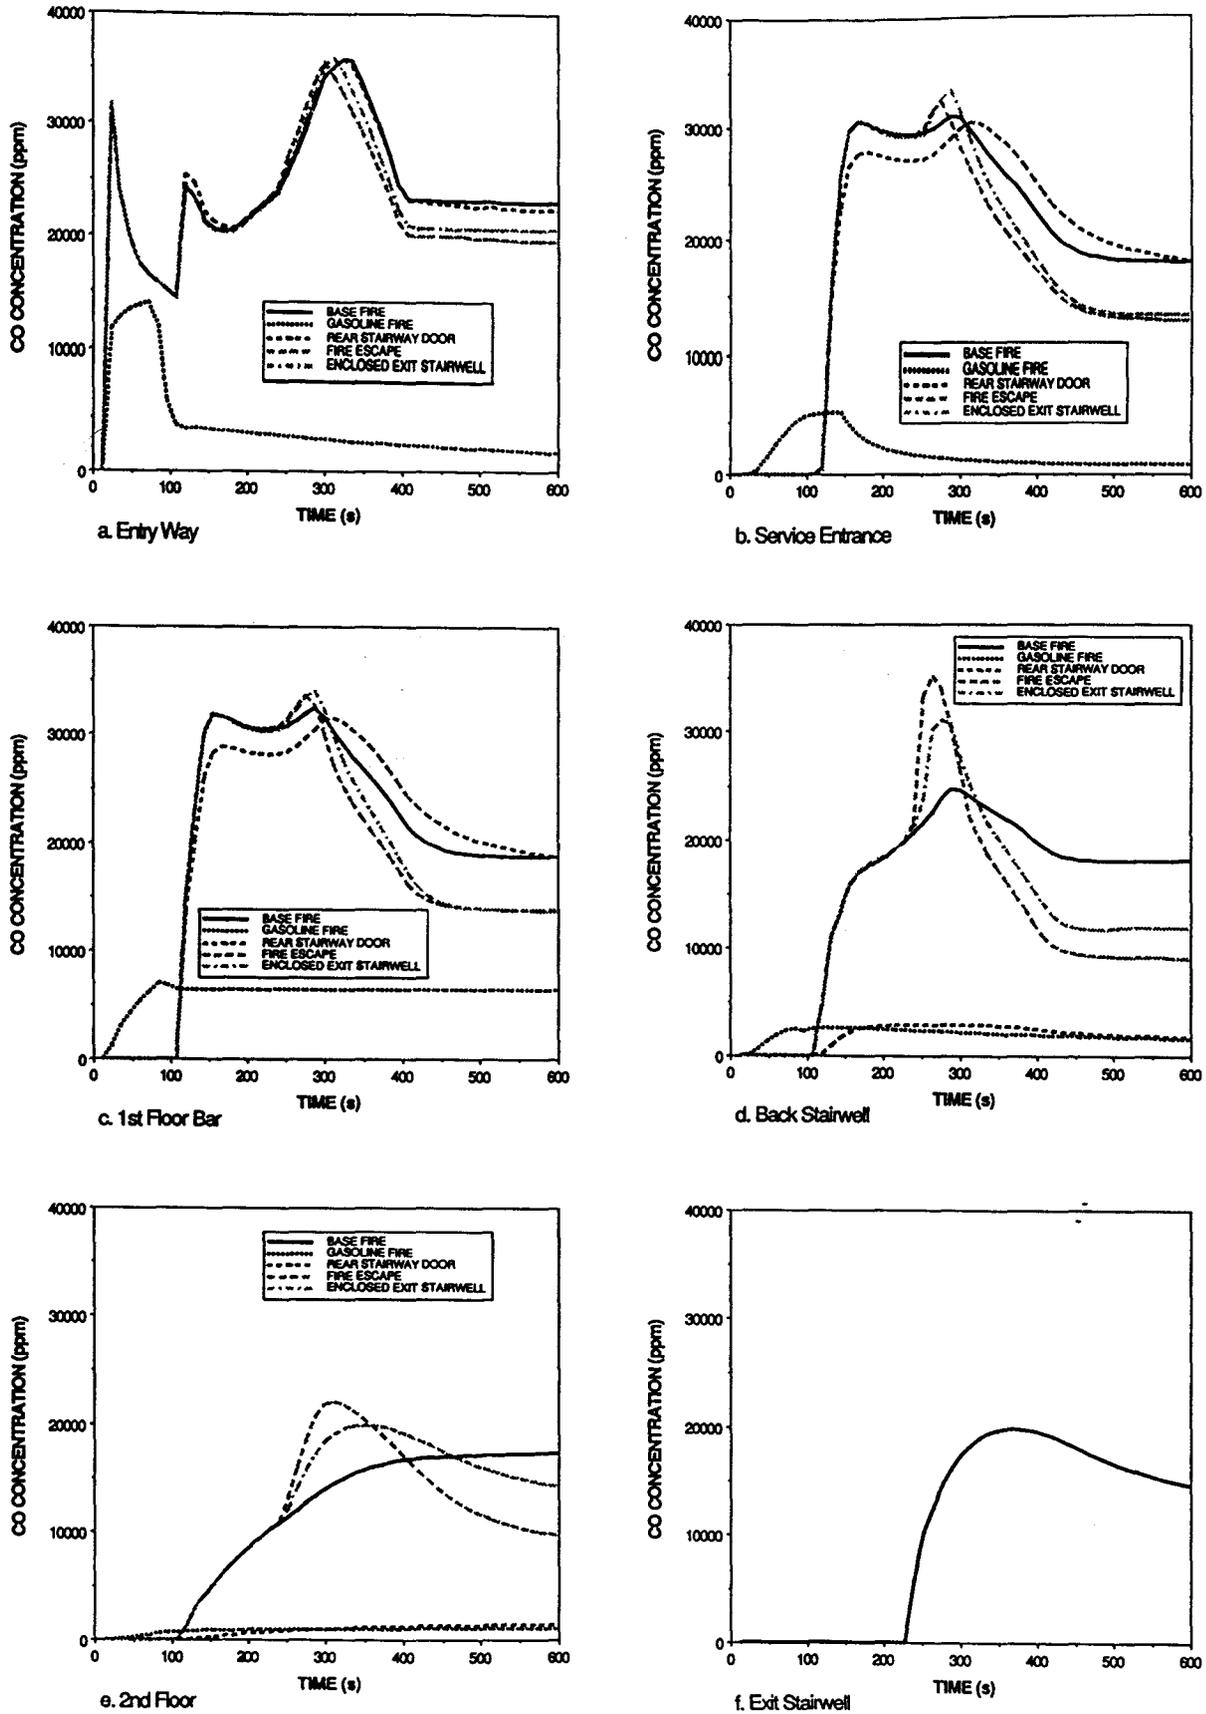
Figure 5. Predicted carbon monoxide concentrations.

To examine this strategy, a (closed) solid wood door at the first floor entry to the stair was assumed. An effective crack width of 1.3 cm (0.5 in) was assumed over the height of the door to represent the gap to the frame. The simulation run for these conditions showed a reduction in the predicted temperatures within the rear stairway and the second floor (Figure 1, d and e), as expected. The temperature of the first floor bar (Figure 1c) was also lower, as less flow up the stairs reduced the ventilation rate through the front door reducing the oxygen (Figure 4, a and c) and the burning rate (Figure 2, a and c) in both the entry and the bar. The CO levels upstairs (Figure 5e) were significantly lower, and the levels on the first floor (Figure 5c) were reduced due to the lower burning rate.
