INVESTIGATION REPORT ON THE MGM GRAND HOTEL FIRE

**Las Vegas, Nevada
November 21, 1980**

Prepared by
RICHARD BEST
NATIONAL FIRE PROTECTION ASSOCIATION

DAVID P. DEMERS, P.E., DEMERS ASSOCIATES, INC.
CONSULTANT TO NFPA

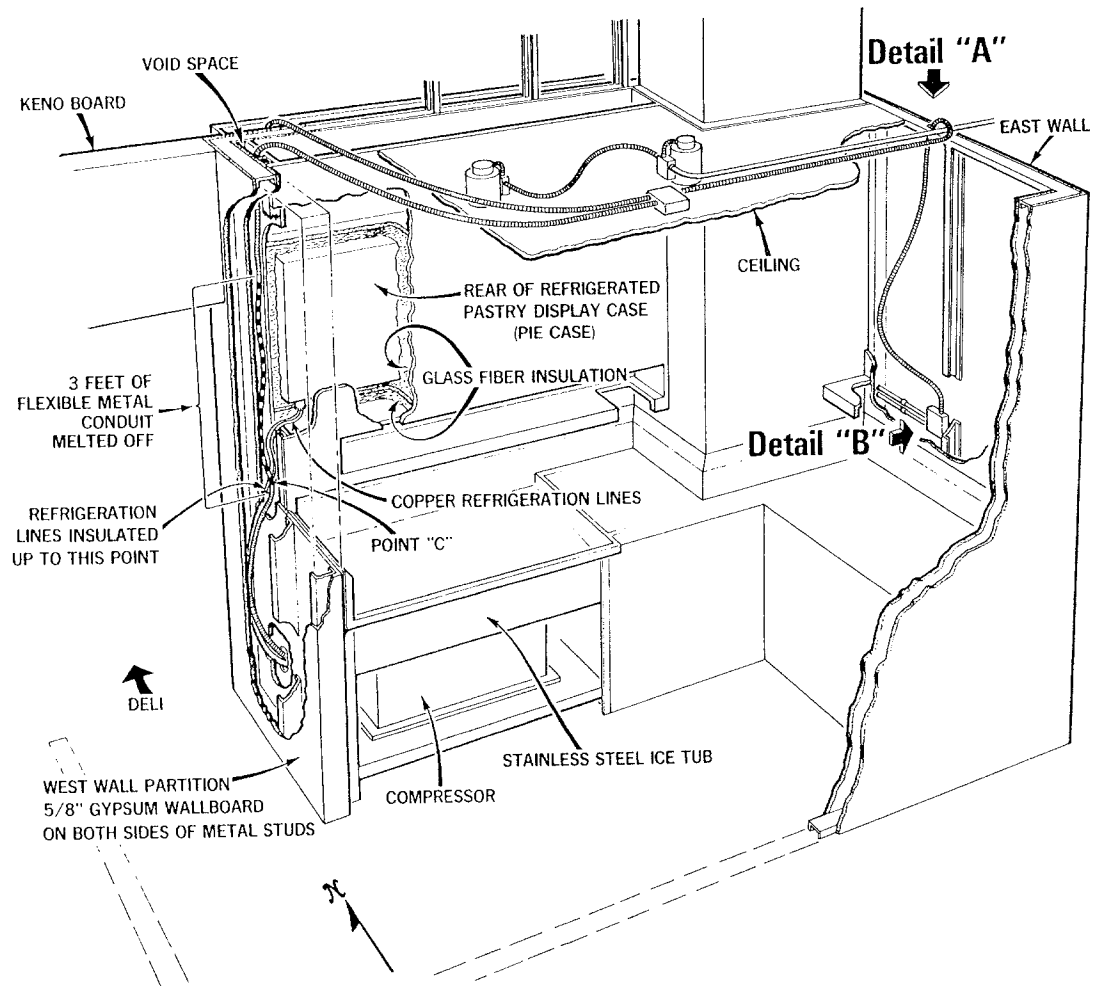
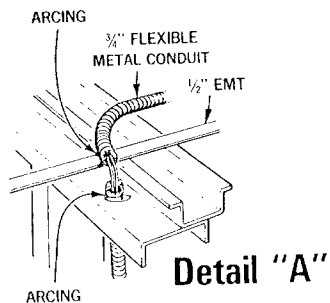
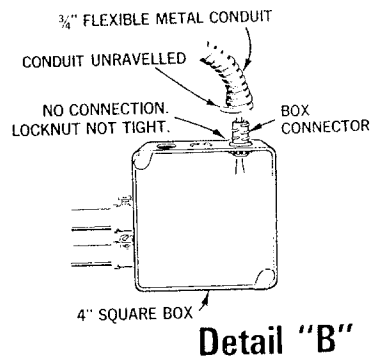
Figure 20. The Deli serving station.

the flexible metal conduit to the ½-inch electrical metallic tubing at the serving station east wall where arcing between the ½-inch electrical metallic tubing and the ¾-inch flexible metal conduit took place. (See Figure 20, Detail "A".) Further arcing and heating took place where the flexible metal conduit passed through the horizontal metal framing member. The length of the flexible metal conduit between the ground-fault point and the point of contact between the flexible metal conduit and the ½-inch electrical metallic tubing was approximately 16 feet.

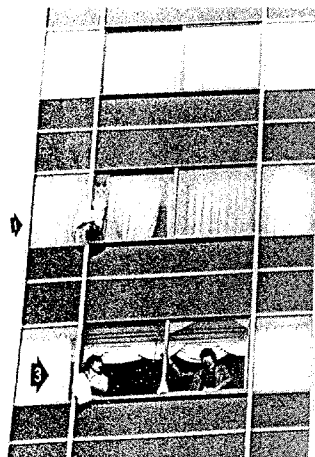
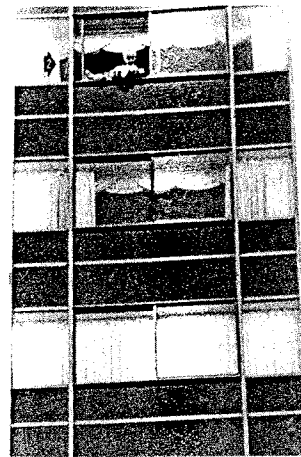
View of guests at windows shows variety of window conditions. (1) Window open to stop was extent of operation without removing stop. (2) Window open to stop, glass removed. (3) Window closed and two glass lights broken. (Credit: Las Vegas SUN)

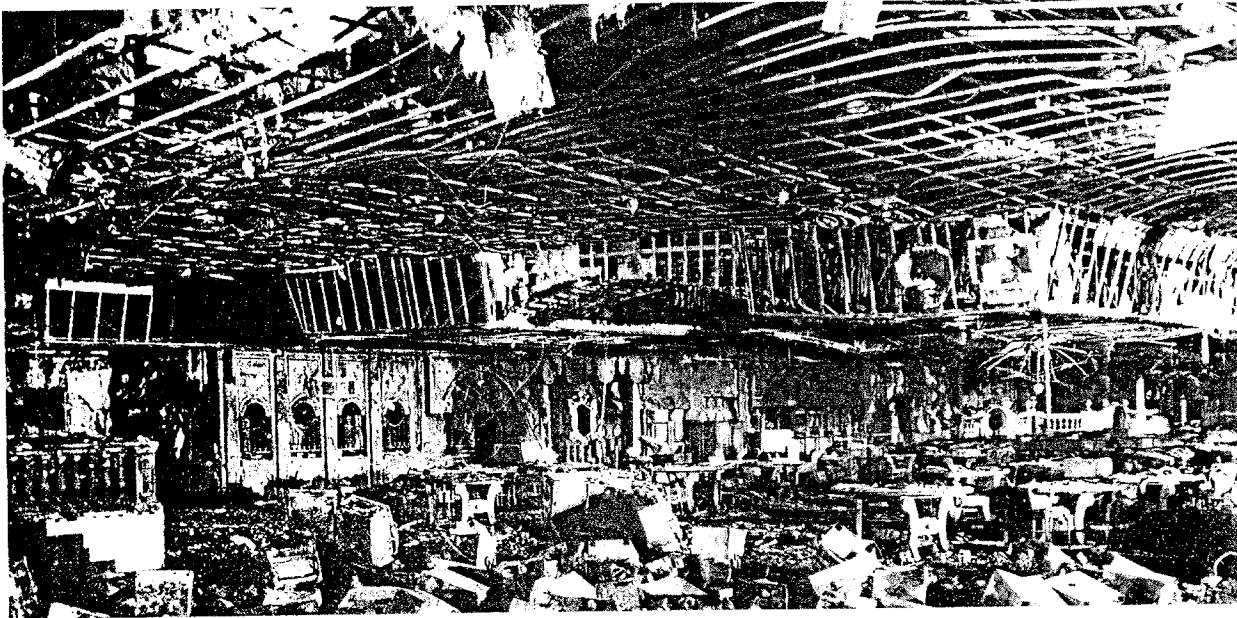
Looking toward southwest in Main Casino, damaged slot machines are at bottom of photo. the eye in the sky was the lower ceiling section. (Credit: Las Vegas Metropolitan Police Dept.)

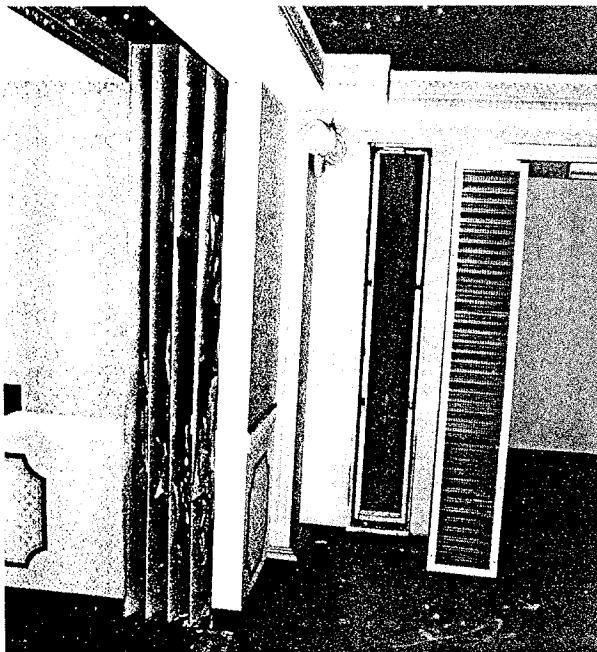
In high-rise tower, note air transfer grill fire damper unit removed and accordion fold metal at seismic joint. (Credit: NFPA)

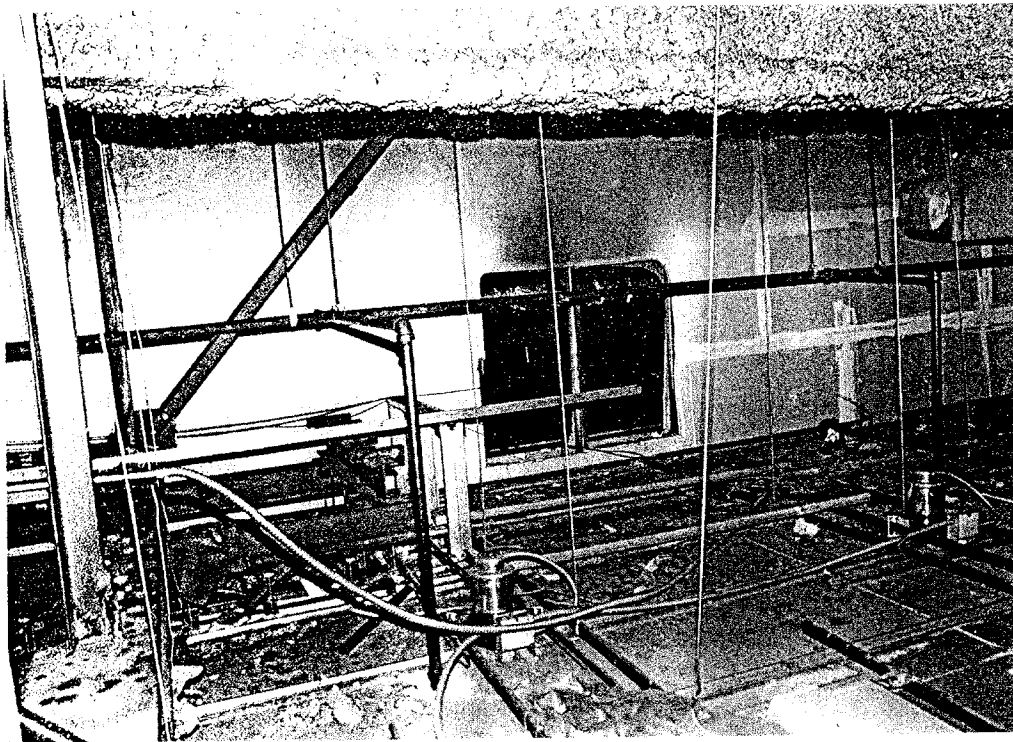
View of opening in partition above Casino level ceiling; ceiling space above Hall of Fame is on other side of partition. Photo taken near E1 stair. (Credit: NFPA)

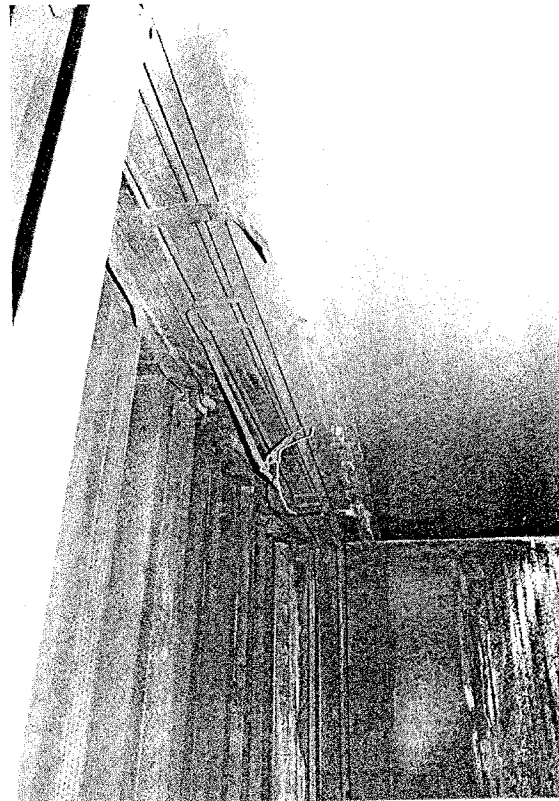
to various penetrations in the enclosures. Fire dampers were provided in the supply ducts and return air control assemblies where they penetrated the mixing room walls above the Casino ceiling. The automatic (fusible link-activated) function of fire dampers for two return air control assemblies had been impaired prior to the fire in the easternmost mixing room. This was done by bolting steel straps across the dampers so they could not close. In addition, it was noted that several dampers had fusible links replaced with steel wire.

View of fire damper with straps arranged to prevent damper from closing. (Credit: NFPA)

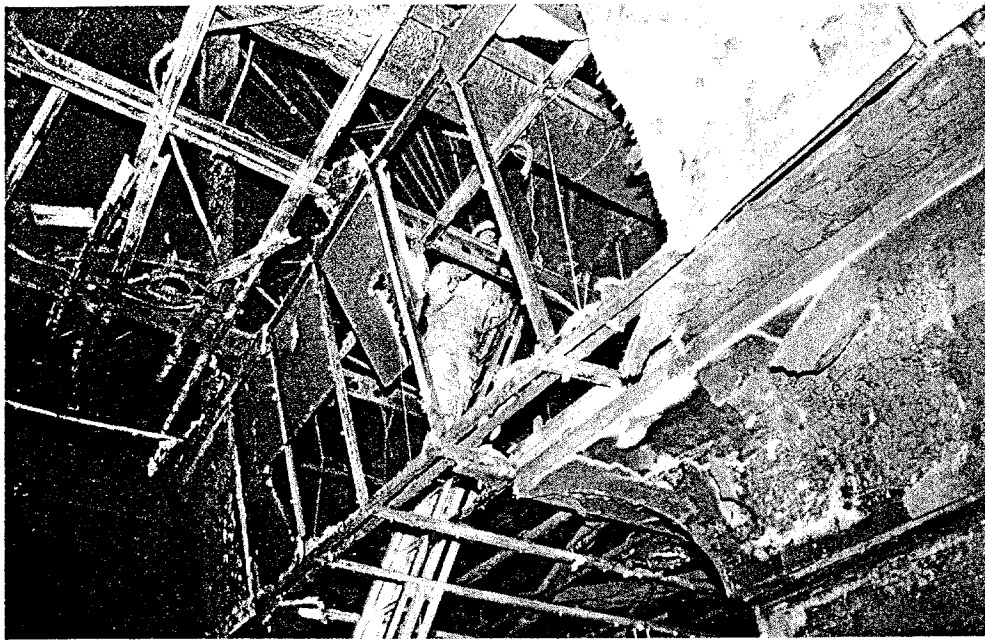
View from the Casino level shows fire investigator on ladder in concealed space directly beneath the base of W2 stair. (Credit: NFPA)

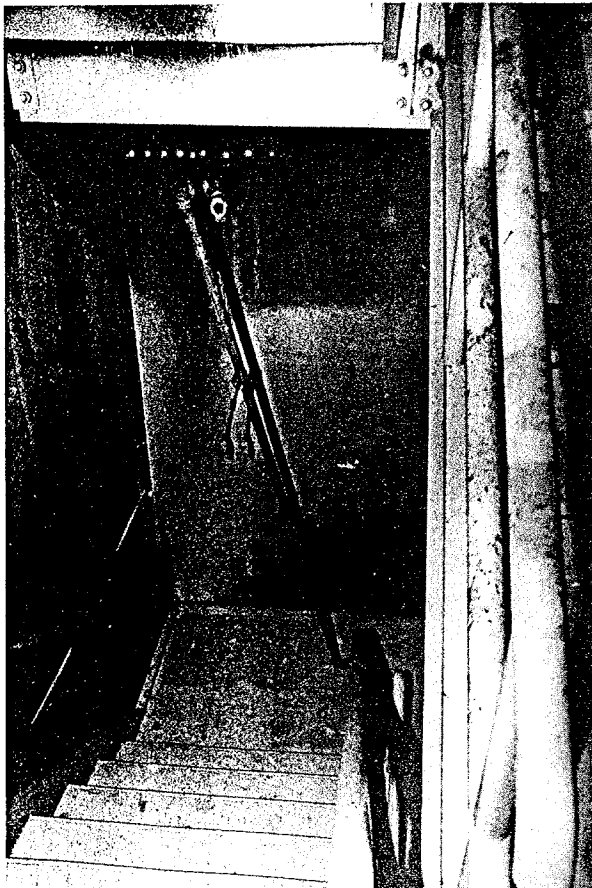
From about the 5th floor landing looking down S1 stair toward exit passageway. Note collapsed sprinkler piping. (Credit: NFPA)

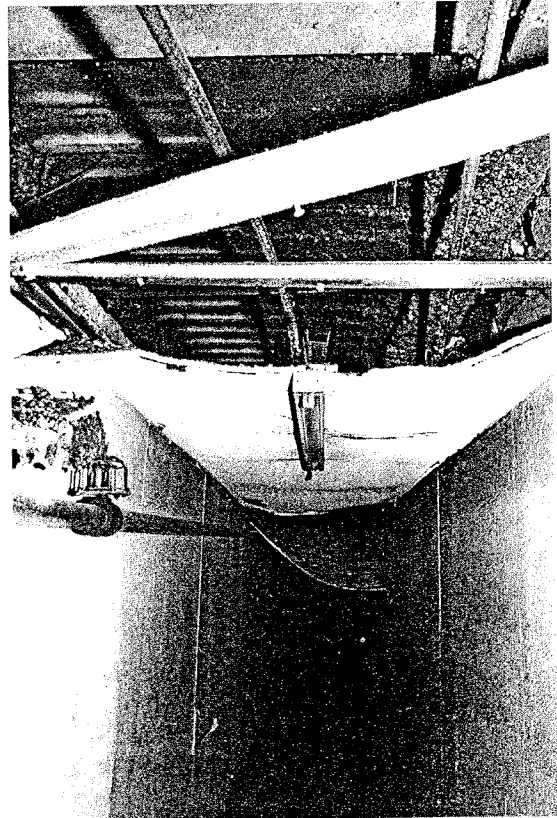
Exit passageway from S1 stairway, note single thickness gypsum wallboard ceiling and sprinkler piping pulled from ceiling (Credit: NFPA)

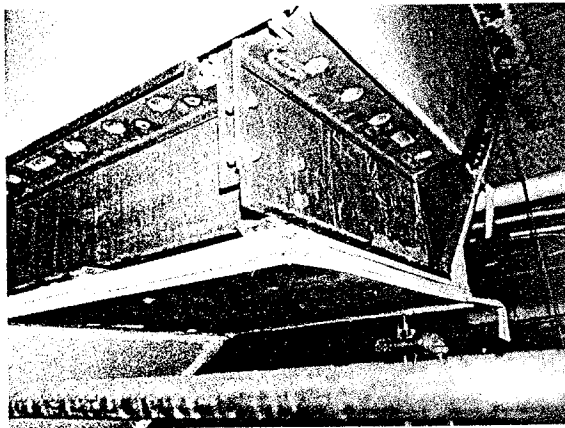
and one layer of $\frac{5}{8}$ -inch gypsum wallboard for ceilings. In many places the enclosures were not complete which resulted in spaces of approximately $\frac{1}{8}$ inch in width running the entire length of the stair stringers. In addition, in many locations fire protection for the steel components of the stairs was nonexistent. (See Photo top left, page 57.) These spaces, along with the lack of fire-resistance protection for the stairs, openings covered with nonrated sheet metal access panels into the stairways and exit passageways and insufficient quantities and thickness of gypsum wallboard, resulted in inadequate protection of stairways and exit passageways. These deficiencies were confirmed for the S1, W1, and E1 stairways.

View of stairway EI base from the concealed space above Casino level ceiling. Note lack of protection of steel members and openings to stair interior. (Credit: NFPA)
