3.5 República Cromañón, Argentina, 2004

In the late evening of the 30th of December 2004 a fire broke out in the nightclub República Cromañón in Buenos Aires, Argentina. The nightclub was hosting a popular rock band. The fire broke out due to a flare that was lit by somebody within the crowd of fans. In total 193 people died. The exact number of injuries is unknown and reports vary widely. In the newest

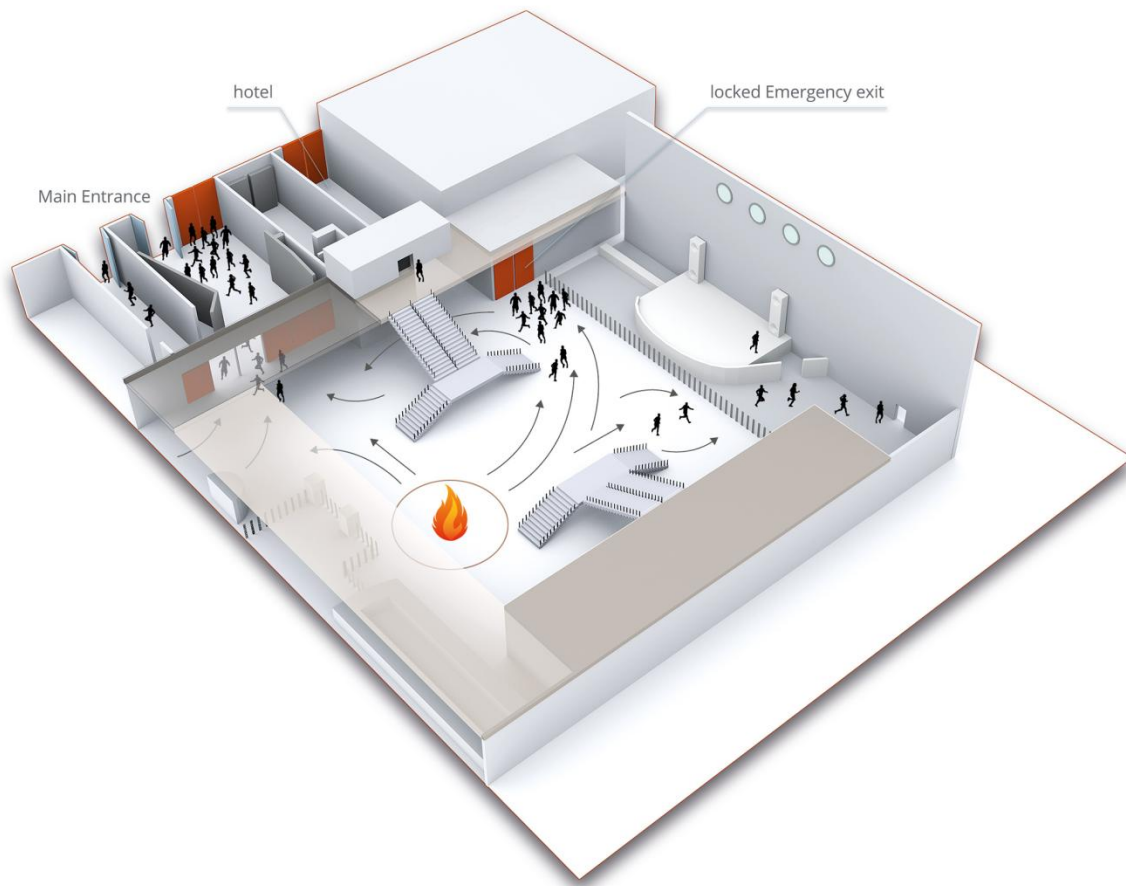
The nightclub was located in a two-storey building. The main entrance was located on the lower floor and led to the outside. Right behind the main entrance there were six doors leading to the main area of the nightclub. Four of them were locked. A connection to a nearby hotel was on the same level. The emergency exit on the lower floor was locked with a padlock [74]. This exit was marked with an illuminated exit sign. Another exit was located next to the stage but was not used by many. A fence in front of the stage was blocking the way to this exit.

Figure 6: Layout of the República Cromañón nightclub; The flame indicate the origin of the fire; Figure based on [75]

The nightclub did not have an approved fire safety concept. The fire was started by a pyrotechnical device. The choice of materials led to an easy ignition as well as to a fast spread of fire and smoke. There was no evidence of a detection and alarm system, an automatic suppression system or a smoke and heat control system. The fire extinguishers, except for 1 out of 15, were not functioning. The nightclub was overcrowded. The emergency exit on the lower level was locked. Of the 6 doors leading to the main entrance four were locked which hindered the evacuation even further. The exit at the stage was blocked by a fence. Shortly after the fire started the lights went out making orientation and evacuation more difficult.
