3.3 Santika, Thailand, 2009

Description of the Building and the Situation Prior to the Fire

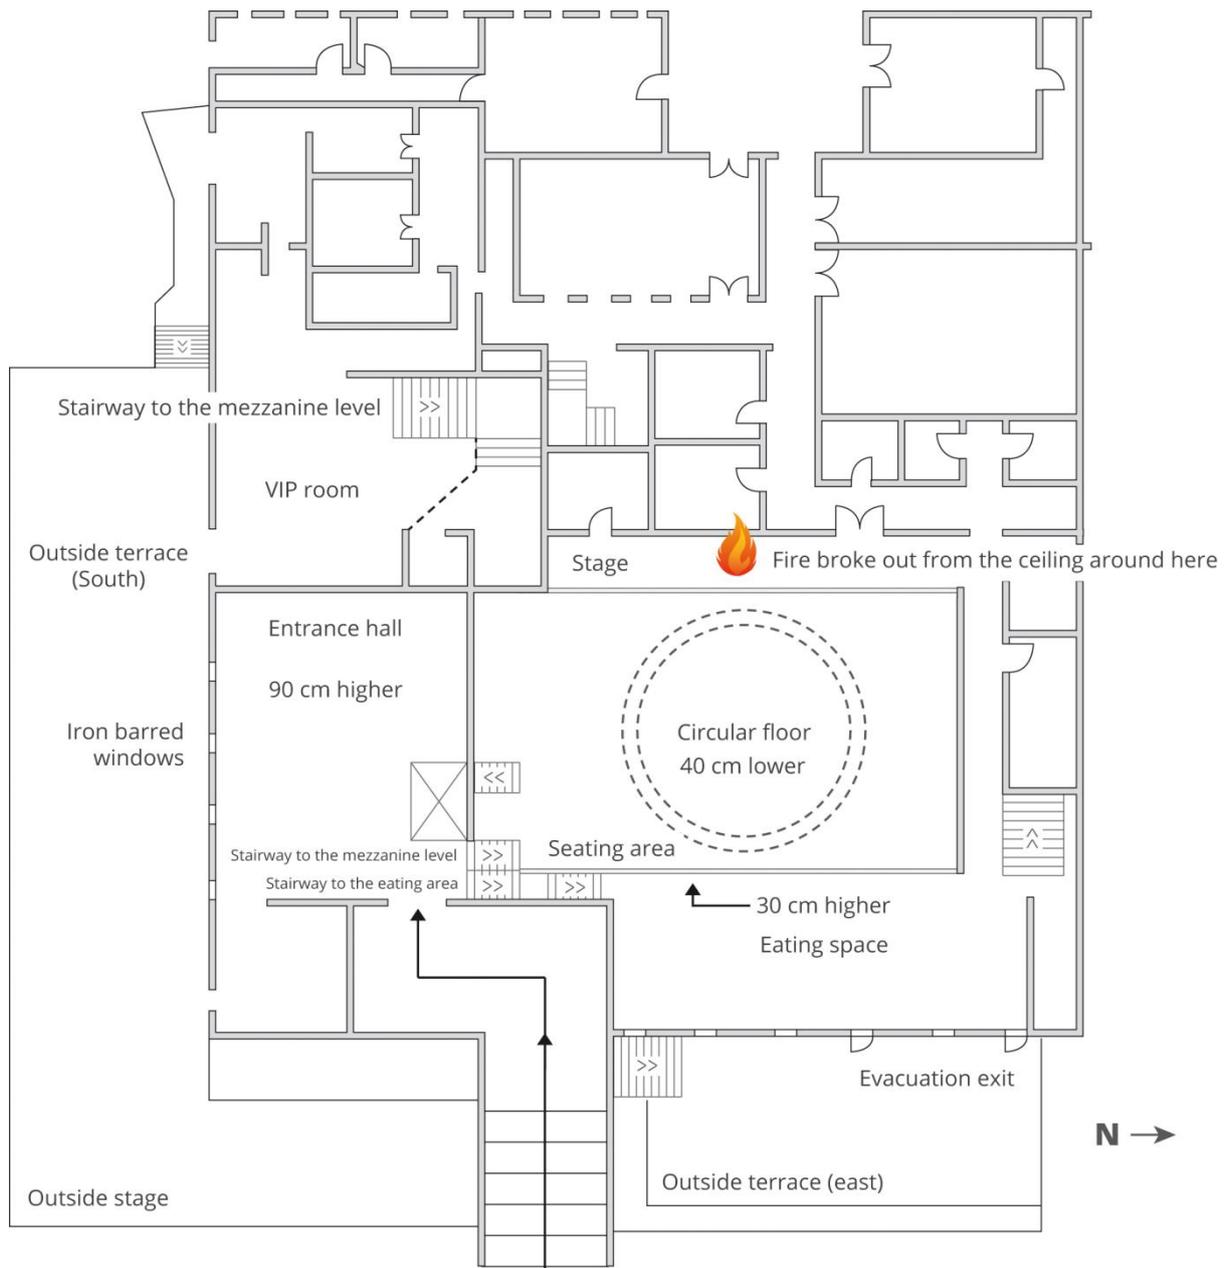
Figure 5: Floor plan of the main floor of the Santika nightclub; The flame indicates the origin of the fire; Figure based on [65]

The building had three major evacuation routes, the main entrance and two 70 cm wide doors leading to the east side terrace [65]. There were corridors behind the stage that could have been used for evacuation purposes but since the fire originated in between the crowd and the alternative ways of evacuation it would have been very difficult to exit there without a member of the staff who was familiar with the building. On the east side there were six tall and 70 cm wide windows. The height is not specified. Two of these windows served as doors and were part of the major evacuation route. The investigation report is not clear on the condition of the other eastern windows. In the text it says that they did not have a handle to open, but that the glass was broken and the windows used to escape. The layout presented in the report indicates that they were iron barred. There was a lobby leading to the southern terrace. On the south side there were four windows that were secured with iron bars and could not be used for evacuation. There were several windows on the east and south side on the mezzanine level but they were secured with iron bars as well and could not be used for evacuation either.

There were several tables placed in a semi-circular way around the lowered centre of the guest area [65]. Small counters for drinks were placed close to each other. The connection from the seating area to the main entrance was narrow, enough for normal use, but not wide enough for an evacuation.

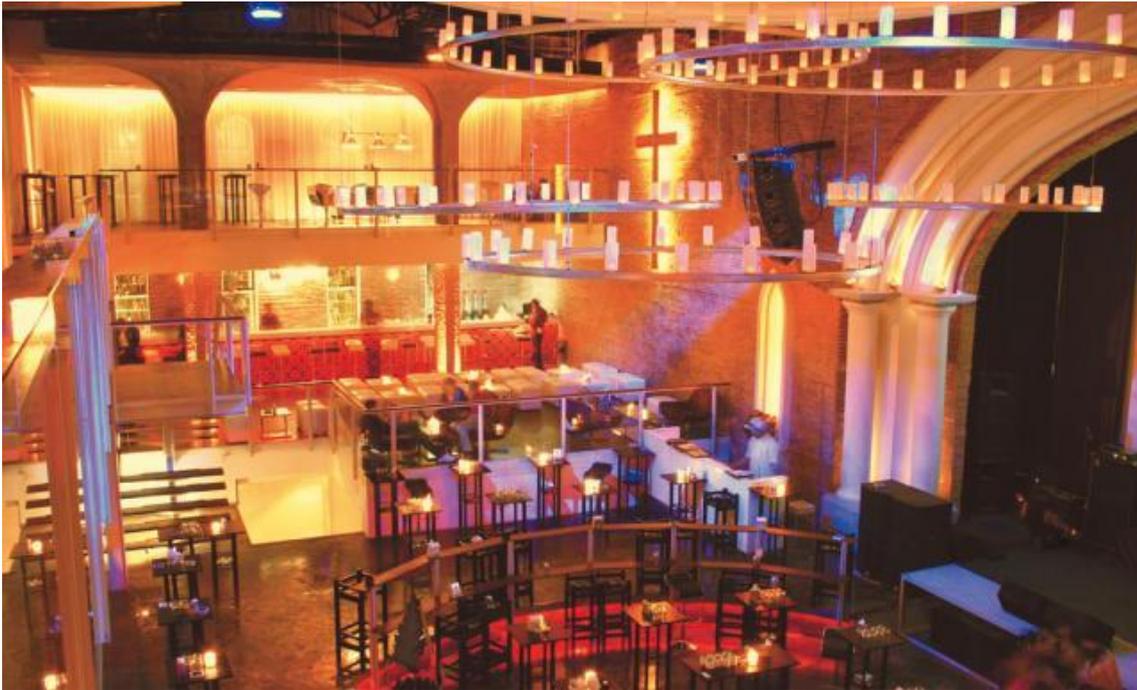
Image 5: An impression of the area around the stage of the Santika nightclub; Image taken from [67]

The following image gives an impression of what the nightclub looked like. It should be mentioned that the picture was most certainly not taken on the night of the incident. In the video of the night no tables in front of the stage can be seen [66].

The fire started minutes after midnight due to a pyrotechnic display on stage which ignited the combustible materials near the ceiling [65]. There were no attempts to fight the initial fire or give guidance for the evacuation. The fire and smoke spread rapidly to the sides of the venue. People became aware of the severity as they felt the radiant heat and saw a cloud of black smoke. Soon after the fire broke out there was a power failure and the lights in the nightclub went out. Since the venue had no emergency lighting and there were only a few emergency exit signs, people had difficulty finding the exits. In the first seconds of the fire people believed that it was part of the show. A few people however, including the performers started to evacuate immediately. A while later “[...] a chandelier with a diameter of nearly 10 meters fell down [...]” from the ceiling and crushed a considerable number of people in front of the stage to death [65]. The exact number is unknown. The chandelier can be seen intact in Image 5 and as debris in Image 7.

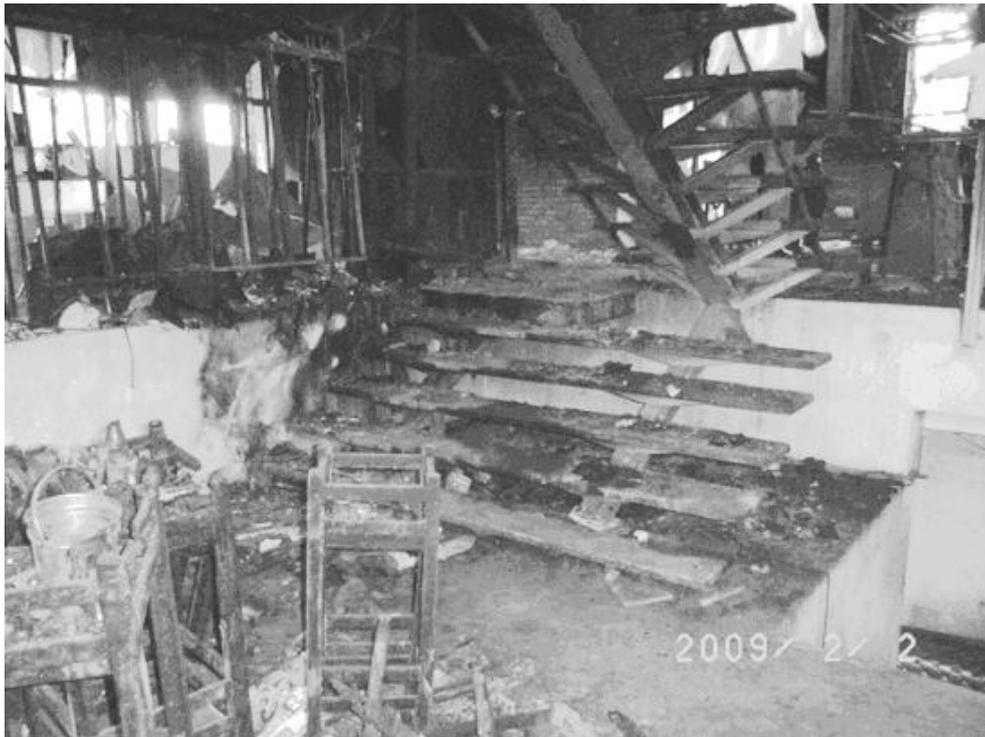
Image 6: The staircase leading to the entrance hall of the Santika nightclub; Image taken from [65]

The staircase leading to the entrance hall where several egressing flows merged resulted in a bottleneck [65]. Thirty-two fatalities were found around the main entrance [68]. In total 55 out of 66 people died in the building while the other 11 died at a later stage.

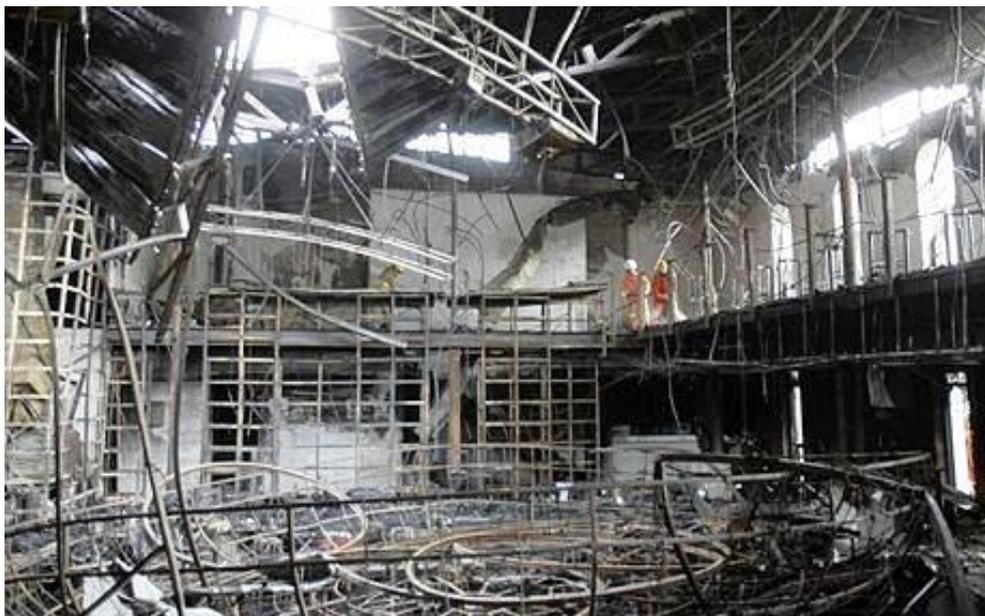
Image 7: The area around the stage of the Santika nightclub after the fire; Image taken from [70]
