## **ANALYSIS OF THE HAPPYLAND SOCIAL CLUB FIRE WITH HAZARD I**

**Richard W. Bukowski, P.E. and Robert C. Spetzler**  
Building and Fire Research Laboratory, NIST  
Gaithersburg, MD 20899

### **SUMMARY**

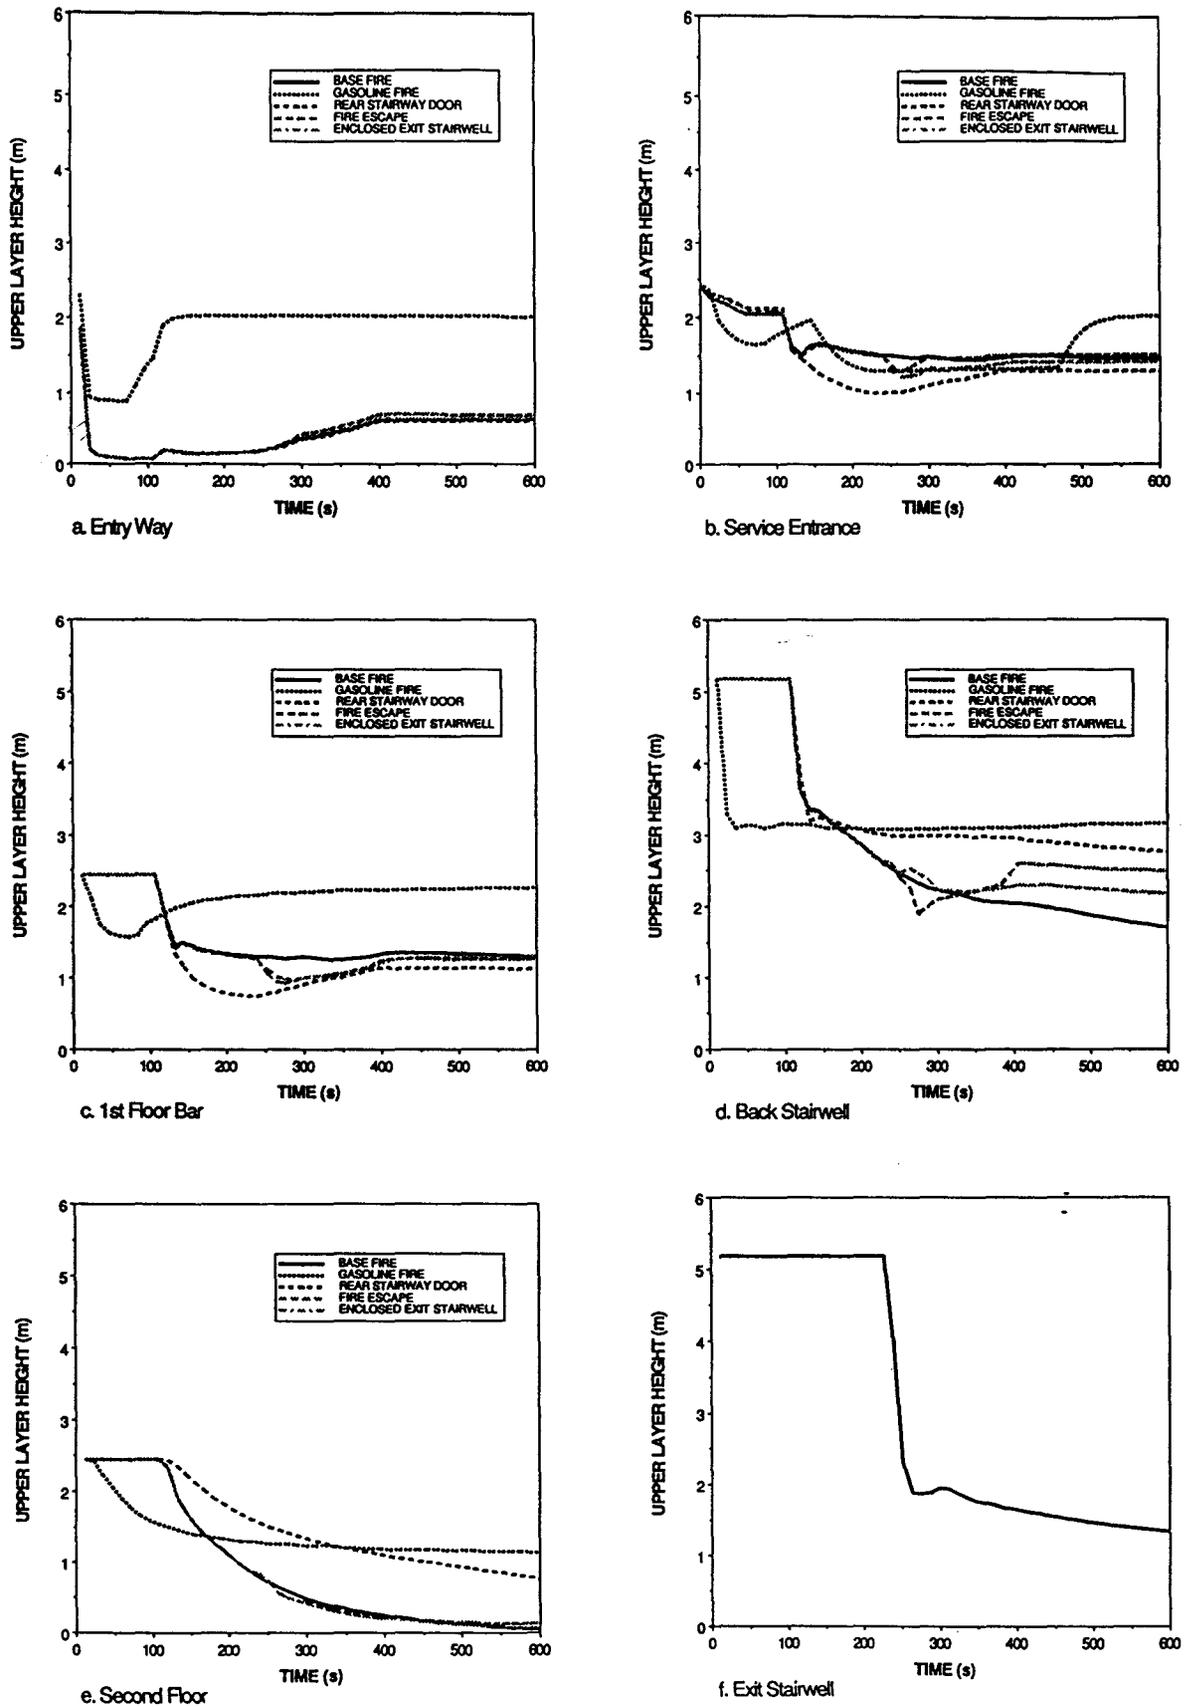
Figure 3. Predicted layer height.

The predicted conditions within the building for the incident (labeled *base fire*) and for each mitigation strategy are presented in the Figures 2 through 5. Data for a single variable (e.g., temperature, oxygen concentration) are presented in each figure consisting of a graph for each room with a curve for each case examined. All graphs for a given variable use the same scale for easy comparisons.
