INVESTIGATION REPORT ON THE MGM GRAND HOTEL FIRE

**Las Vegas, Nevada
November 21, 1980**

Prepared by
RICHARD BEST
NATIONAL FIRE PROTECTION ASSOCIATION

DAVID P. DEMERS, P.E., DEMERS ASSOCIATES, INC.
CONSULTANT TO NFPA

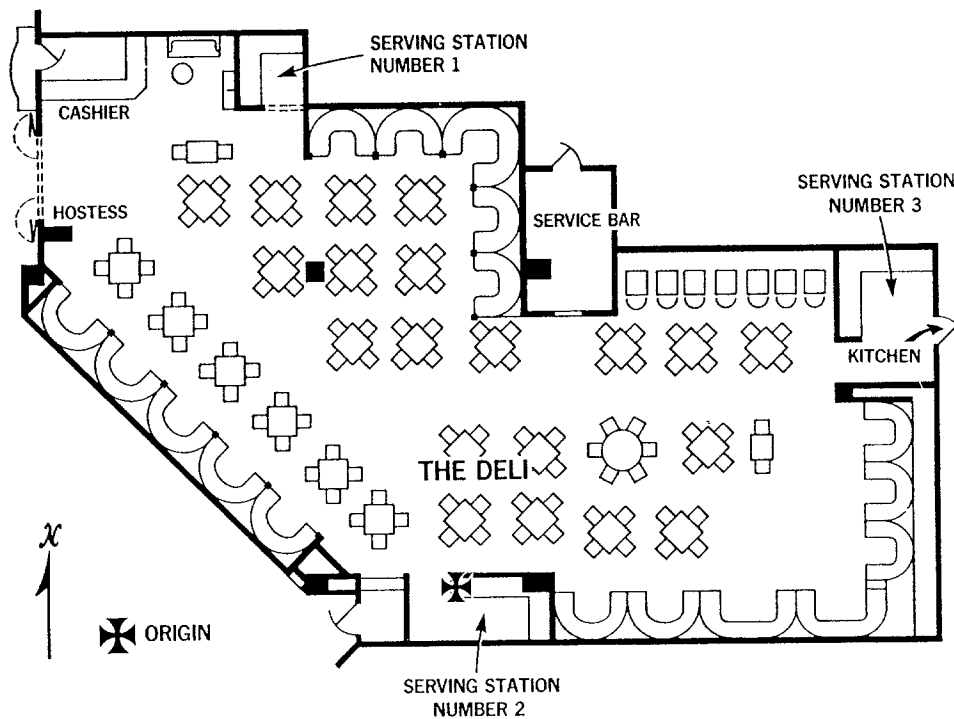
The Deli entrance was just south of the stairs and escalator leading from the Casino level to the Arcade level and MGM Theatre. There were three waitresses' serving stations in The Deli; serving station number one was on the north side, serving station number two on the south and serving station number three was on the east wall. (See Figure 11). "Serving Station" refers to serving station number two in this report unless otherwise noted.

In general, the fuel load in The Deli and Casino areas was provided by contents in addition to previously described interior finishes. The contents of The Deli, which was about 3,500 square feet in area, included free-standing chairs padded with what appeared to be polyurethane foam. Along the south wall were wrap-around booths, which also appeared to be padded with thick polyurethane foam and covered with a vinyl material. (See Figure 11.)

Figure 11. The Deli floor plan.

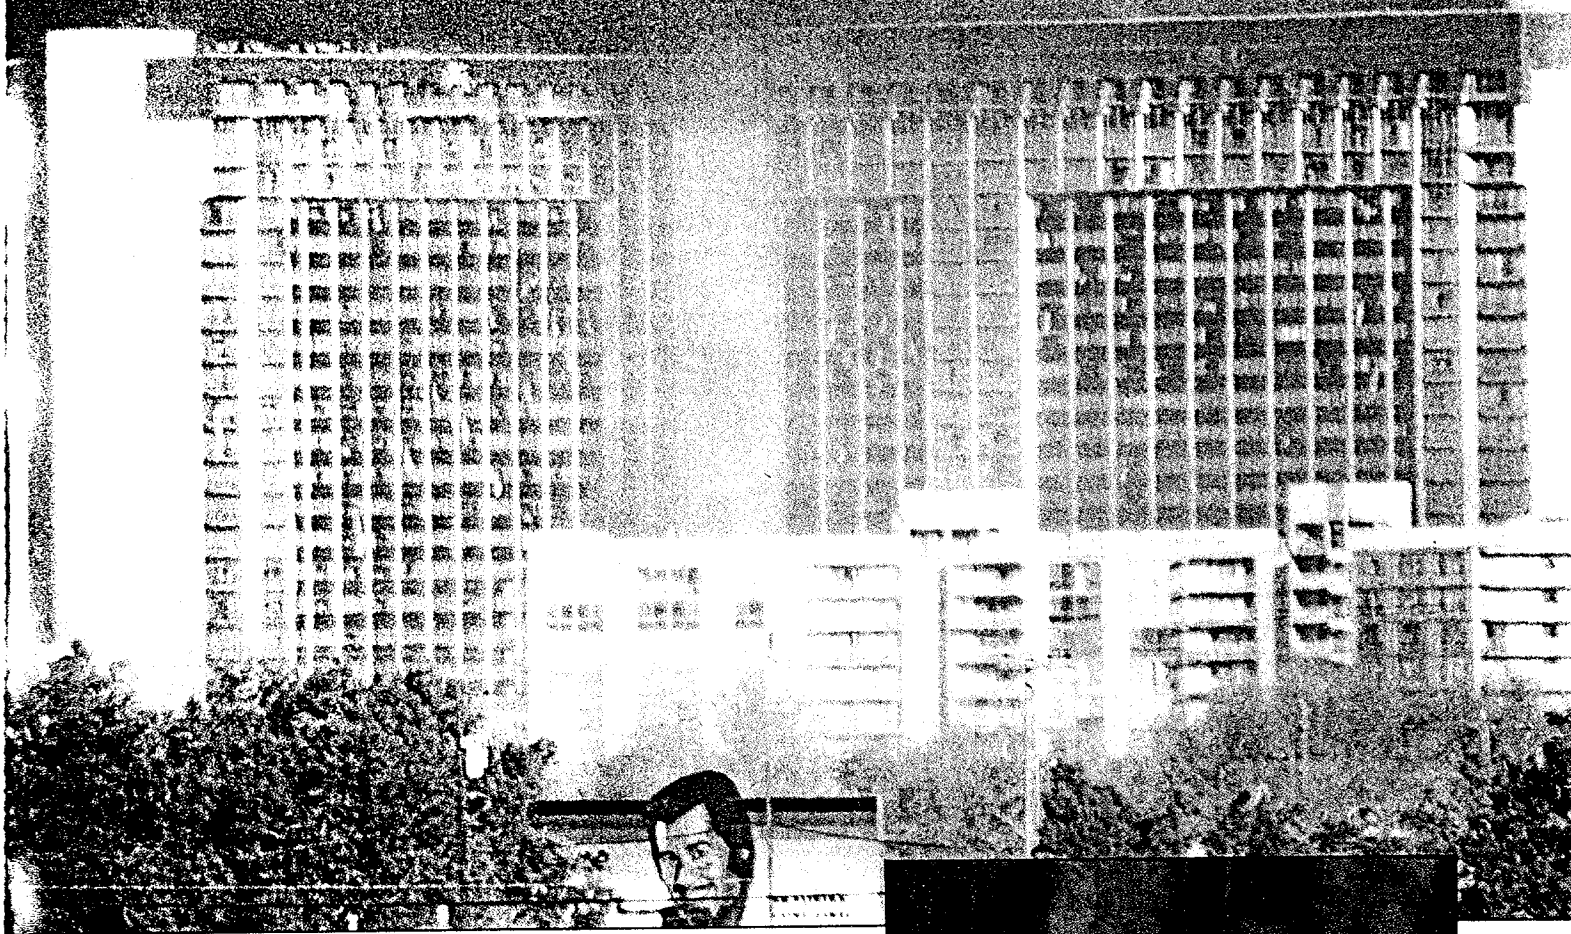
TOP: 7:40 am. View from southeast shows occupants on roof of south wing. INSET: Smoke vents activate on roof of fly gallery of MGM's Ziegfeld Room. (NOTE: The times in this series of color photographs were estimations by the photographers.)

Several times during operations, hotel security reported a fire on the roof above the area of a stage. Actually, this was smoke which was discharging from smoke vents on the roof of the Ziegfeld Room fly gallery designed for that purpose. (See Figure 1 and Photos top, page 18; mid right page 18.)

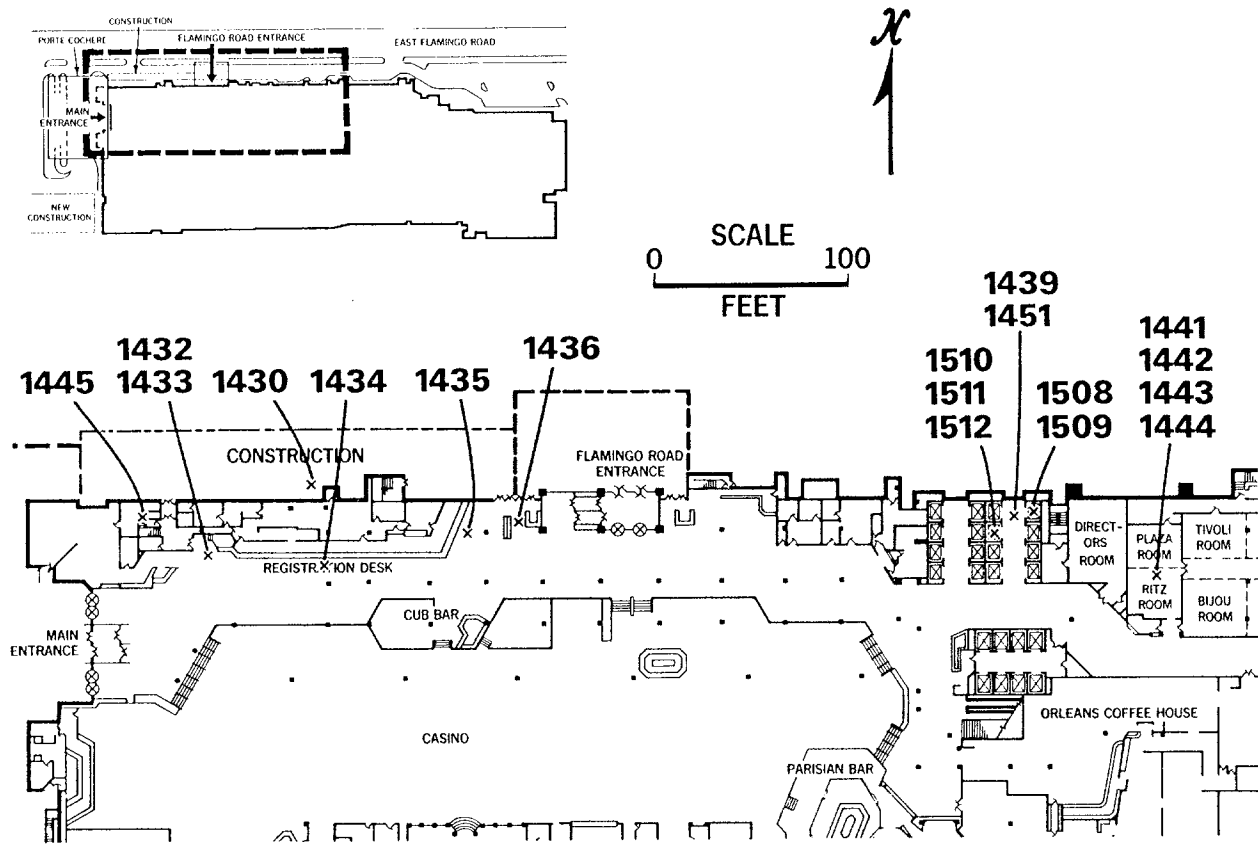
The locations of 18 victims on the Casino level are shown in Figure 17. Six victims were found in the Registration Desk area; three of these victims (case numbers 1433, 1434, and 1436) had extensive body surface burns in addition to smoke and carbon monoxide inhalation. It appears that these victims were overrun by the flame front moving through the Casino. Four victims were found in the Ritz Room, five in elevators and two victims were found in the Casino level elevator lobby. One victim (case number 1430), previously discussed, died of a massive skull fracture when she either jumped or fell from the high-rise tower.

Figure 17. Casino level fatality locations. (Above — area shown in detail)

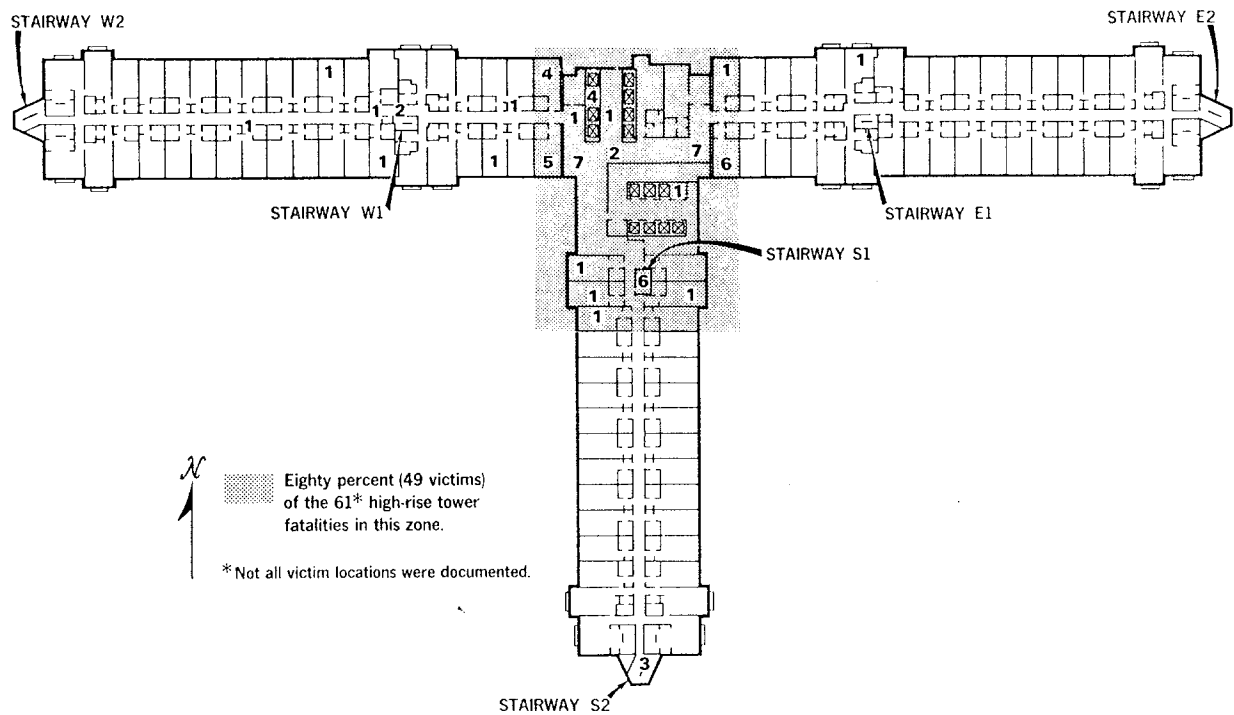
located predominately in rooms and corridor areas between the interior stairs and central core areas on nine floors. (See Figure 18.) On the 24th floor, eight victims were located in the central core. Figures 14, 15, and 16 show location details; victims are identified with Clark County Coroner case numbers. A summary of victim location data is presented in Table 3.1.

Figure 18. The numbers on this figure indicate victim totals in approximate locations on nine floors. (Floors 16 through 26 — see also Figures 14 through 16 and Table 3.1)

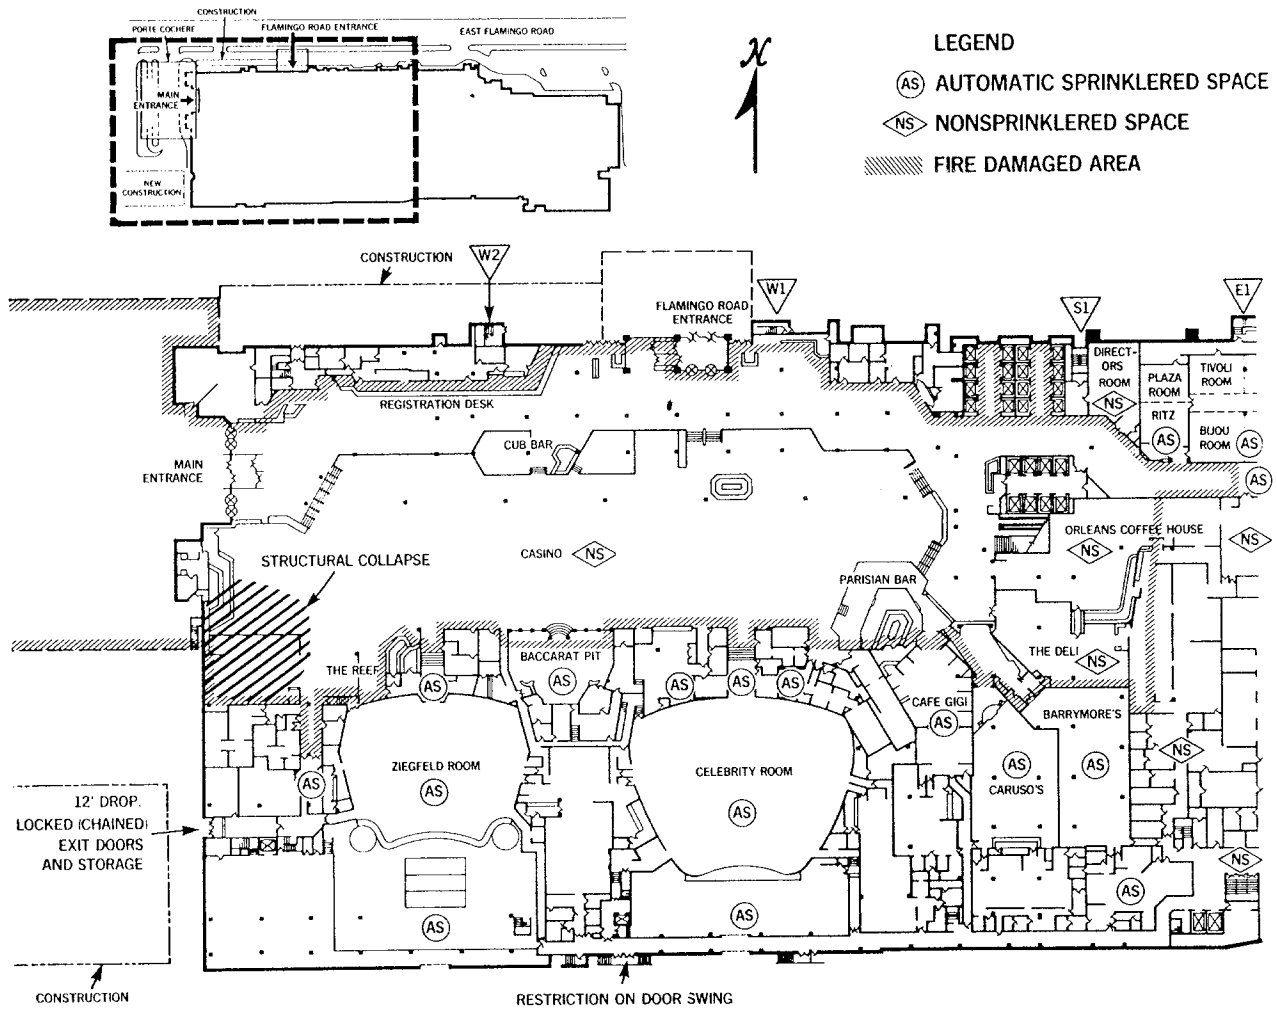
showed very effective stopping of the fire south of the Main Casino where sprinklers were provided. (See Figure 19.)

Figure 19. Damage. (Above — area shown in detail)

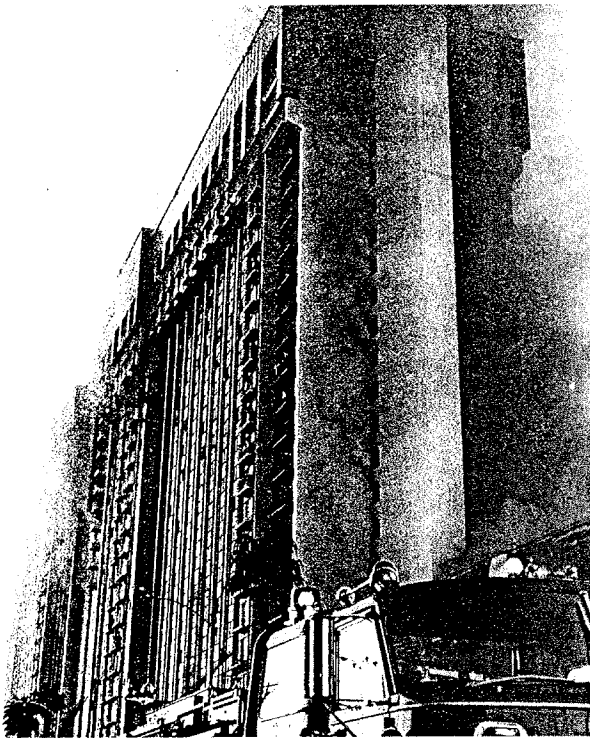
View from northwest early in fire shows smoke from upper floors and "smokeproof" tower, stair W2 (directly above apparatus cab). (Credit: Las Vegas News Bureau)

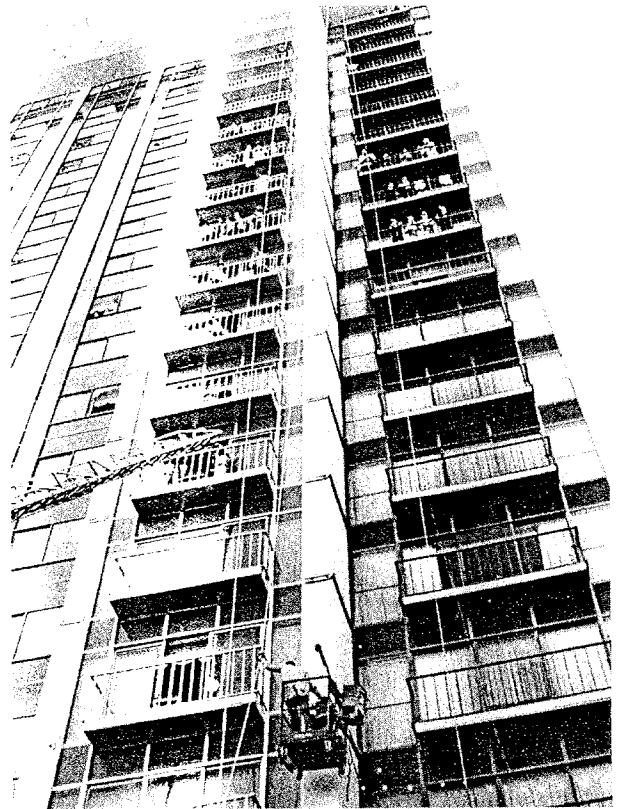
View of north face of hotel shows aerial ladder and construction hoist used to rescue some occupants. All but lowest (5th floor) guest room floors are shown. (Credit: Las Vegas SUN)

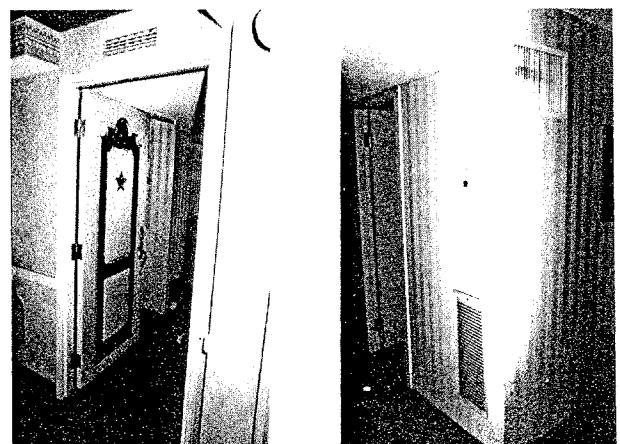
From corridor looking into guest room, fan-coil unit within room took make-up air from corridor through air inlet above door. Fan-coil unit in room delivered air to room (air outlet at top) taking make-up air from corridor and recirculating room air thru air inlet at bottom. (Credit: NFPA)
